April 23, 2010
Mitsui Chemicals, Inc.
Shimonoseki Mitsui Chemicals, Inc.

Report on Accident at Production Facilities at Shimonoseki Mitsui Chemicals, Inc.

Incident Overview

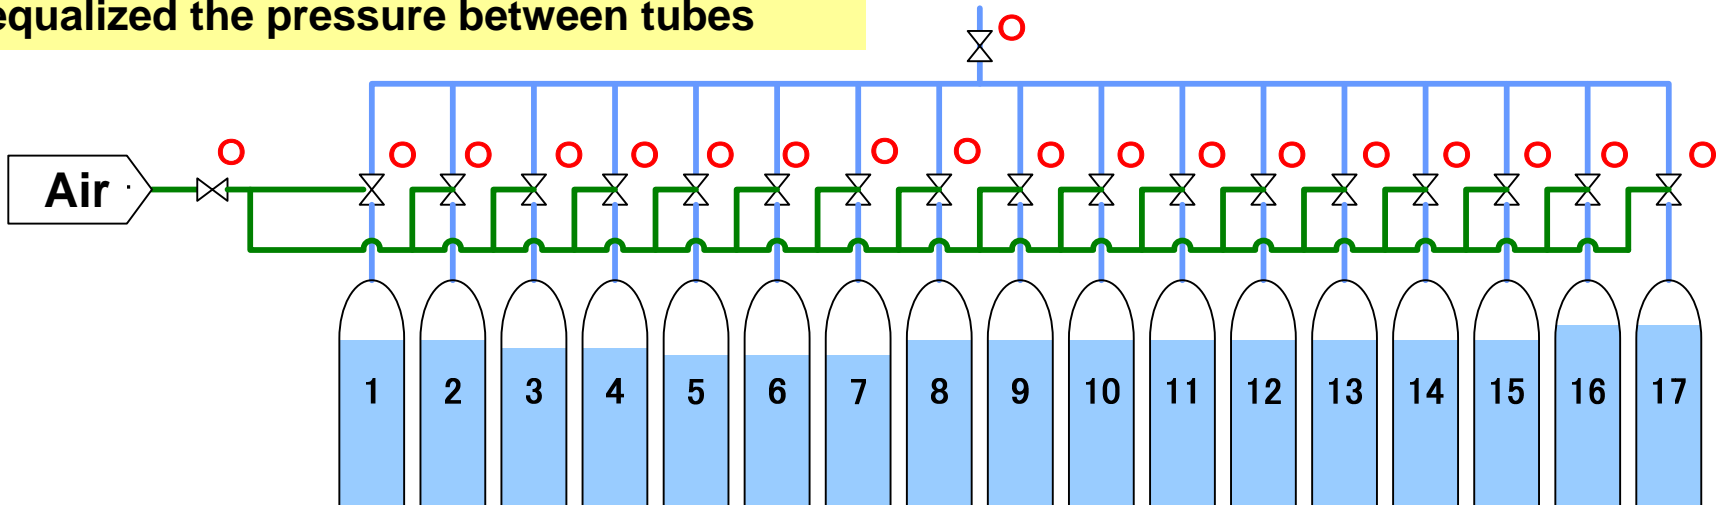
Image for 'the gas flow when all valves were opened at once'

Opened air valve to the tube valves
→ All tube valves were opened at once and equalized the pressure between tubes

We had pressure difference between tubes because we filled 2 or 3 tubes each.

All tube valves were opened at once by supplying air

NF3 in the high pressure tube moved quickly in the manifold into the low pressure tube to equalize the pressure.
